**ANALYSIS OF THE CONDITION OF ECHO
TOWER AZORES FIXED ACOUSTIC RANGE,
AFTER ONE YEAR AT 1500 FEET OF DEPTH**

Naval Underwater Systems Center

Technical Note N-1284

Naval Civil Engineering Laboratory
Port Hueneme, California 93043

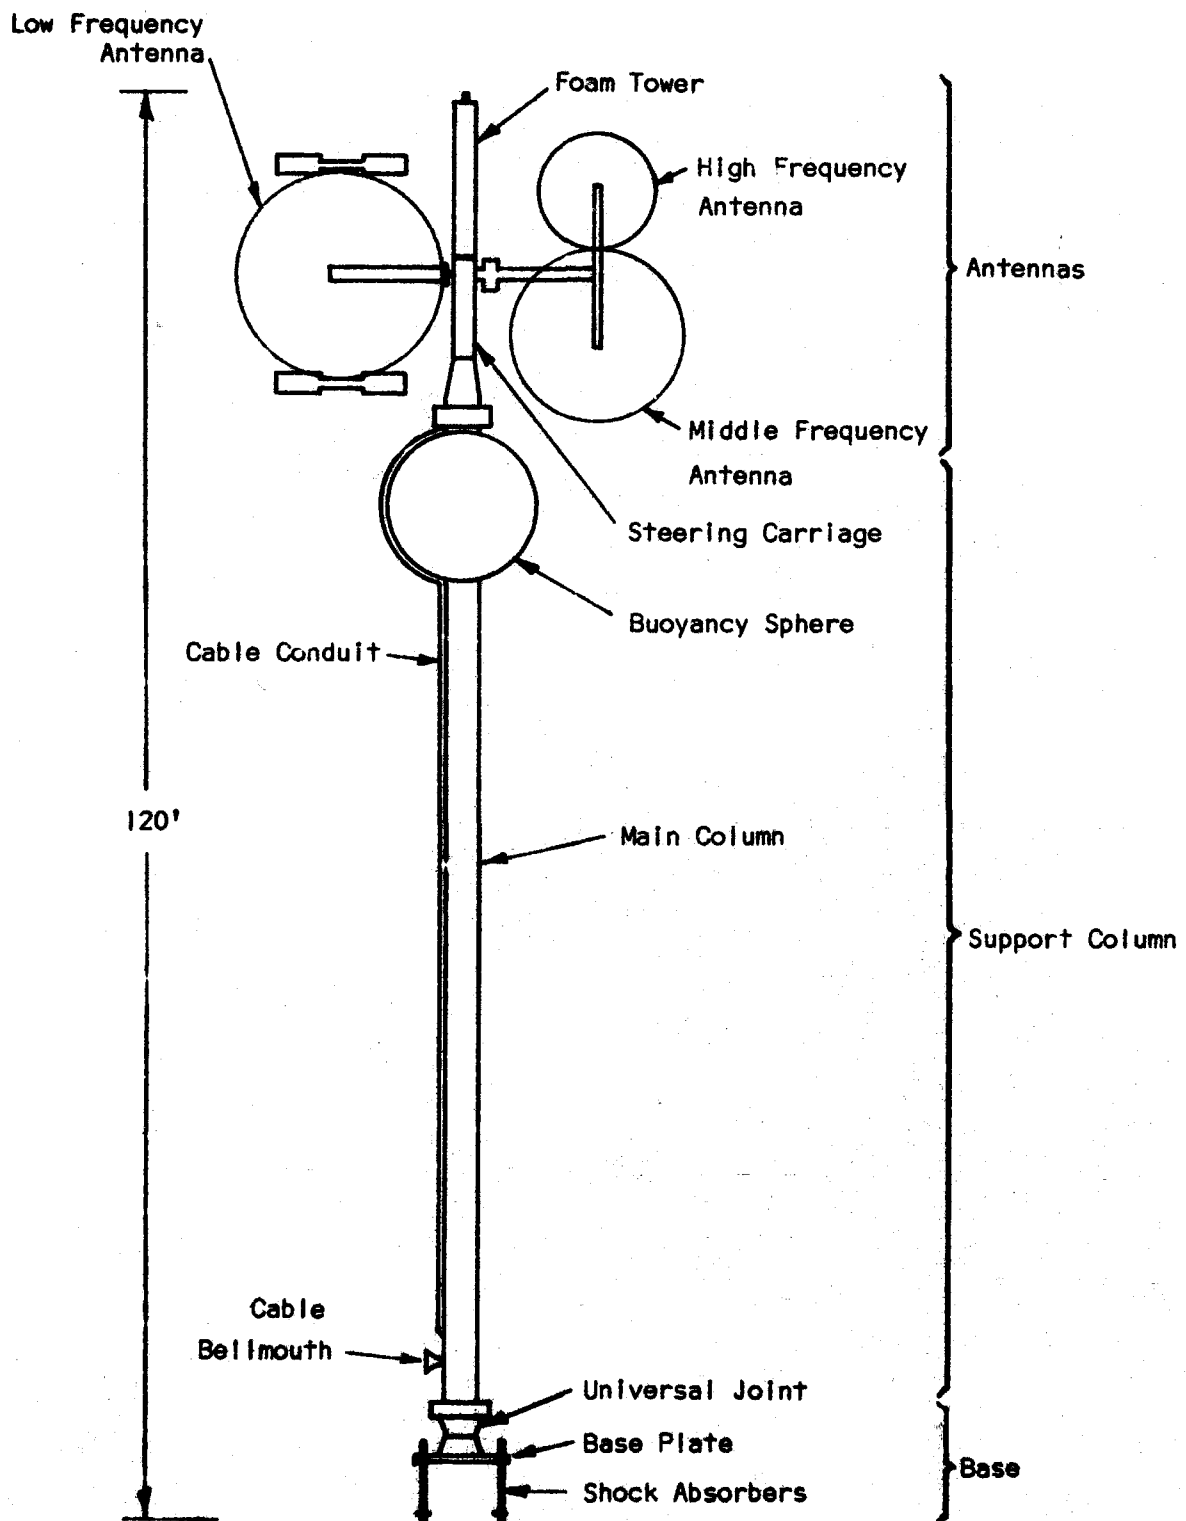
Figure 1. Sketch of Tower.

Approximately 12 hours after being retrieved from depth, an inspection of the upper portion of the tower was made while the tower was still completely submerged in seawater. A sketch of the tower is shown in Figure 1. Depth limitations limited this inspection to the portion of the tower above the center line of the sphere.

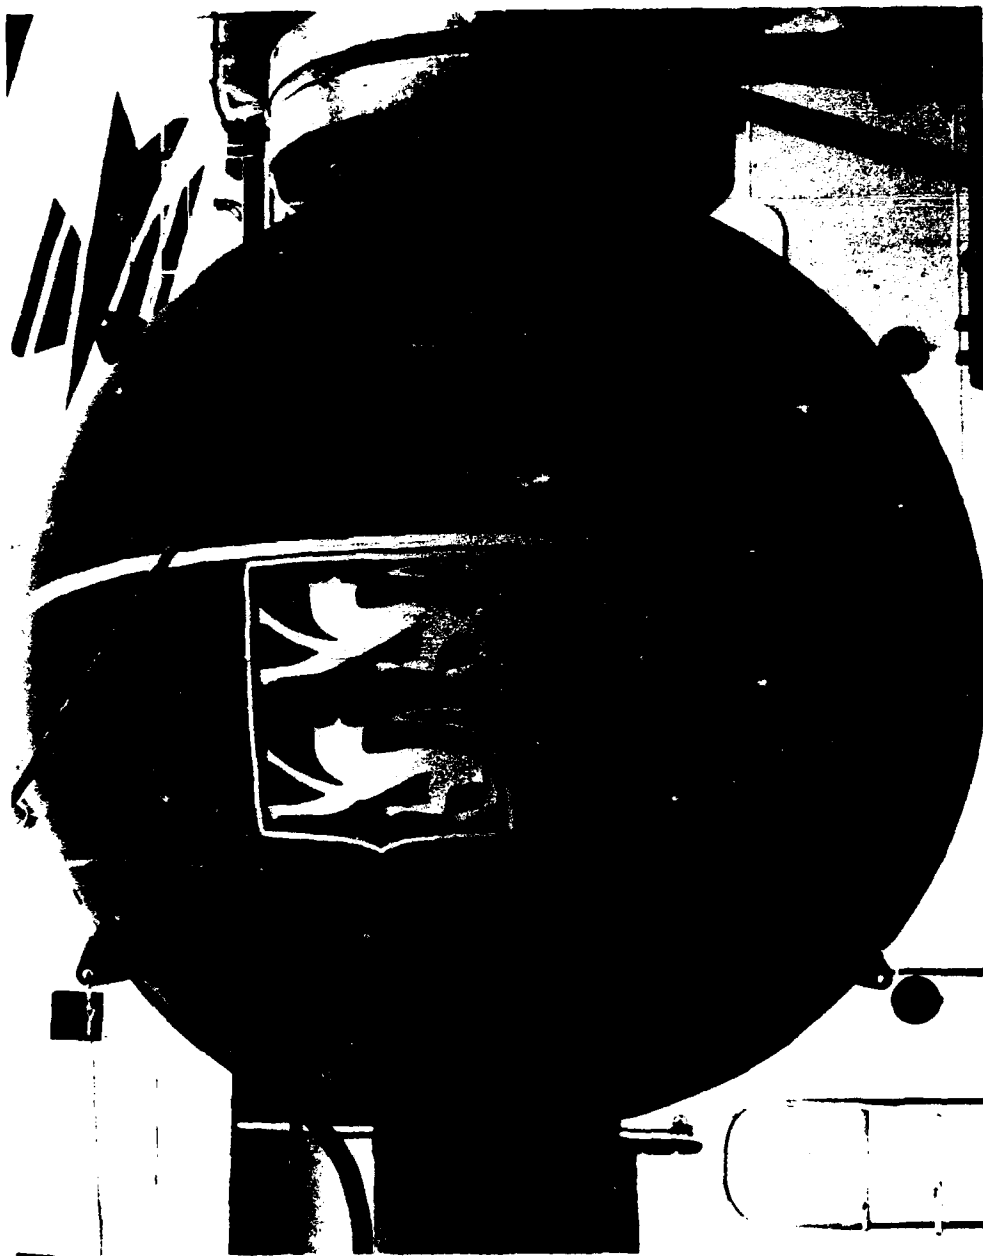
Figure 18. Buoyancy sphere after recoating.

Echo tower was to be reemplaced if its condition permitted. As the damage resulting from emplacement and retrieval was minimal and the amount of corrosion found did not preclude reemplacement, the tower was repaired. The four shock absorbers were replaced with similar units. However, the tips on these units were screwed into place in contrast to the pressed-in units originally used. These screwed-in tips were further secured by welding and are shown in Figure 17. The universal joint was relubricated. The tower base, universal joint, main column and buoyancy sphere were cleaned by an air powered high pressure water jet and recoated with a copper oxide-pigmented rubber-based antifouling topcoat. The yellow enamel identifying marks were reapplied after the antifouling coat had cured. The condition of the buoyancy sphere after repair is shown in Figure 18. The fasteners used to secure the cable conduit to the main column were recoated as required with a rubber based sealing compound. Rusted areas on the steering carriage and antenna support arms were cleaned and recoated with a two coat, polyamide-cured epoxy paint system. The gas generators were replaced. The attacked areas on the antennas were carefully sanded and cleaned before recoating with the same paint system. The gas connections between the ends of the compliant tubes and the gas manifolds were cleaned, the clamps and tubing replaced as necessary and recoated with a two component sealing compound where any rust staining of the connections was noted. Areas of paint failure on the foam tower were repaired using the topcoat of the polyamide cured epoxy paint system. Identifying marks were reapplied to the foam tower. The recoated foam tower is shown in Figure 19. The main lifting eye was cleaned, and then recoated with the two coat polyamide cured epoxy system. The tower was then considered to be ready for reemplacement.

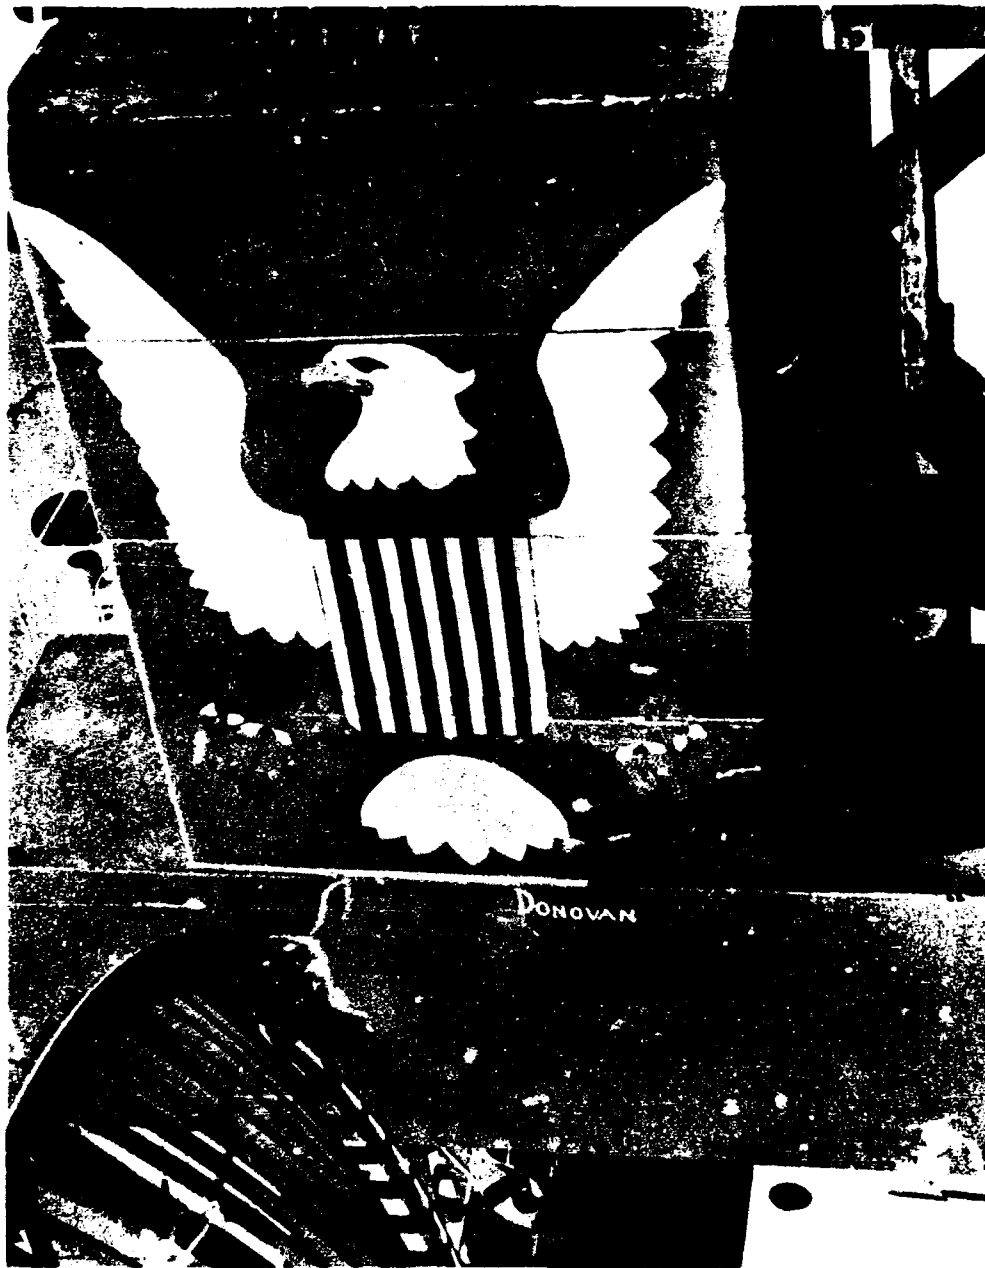
Figure 19. Foam tower after recoating.
